AFFDL-TR-78-79

REPAIR OF BONDED PRIMARY STRUCTURE

BOEING COMMERCIAL AIRPLANE COMPANY
P.O. BOX 3707
SEATTLE, WASHINGTON 98124

June 1978

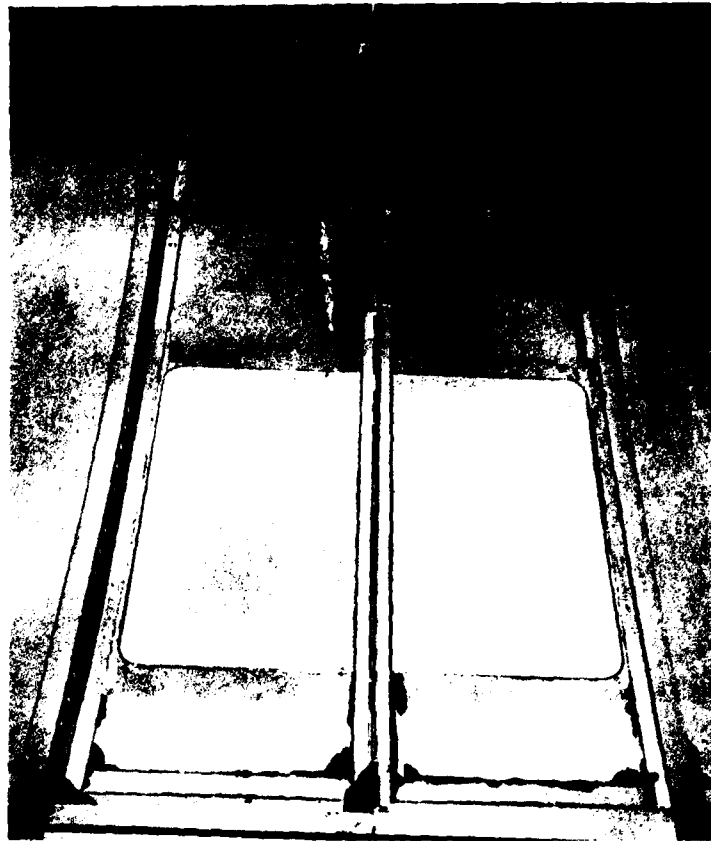
Figure 74.—Completed Repair—External Longeron

Bonding of the repair details was accomplished in two stages. The skin plug and patch plate were bonded in the first stage. This was accomplished using the fiberglass tool to maintain the contour and a vacuum bag to apply the pressure (Fig. 72). The compressed air heater was again used for the cure. The bond was inspected after the cure using a Fokker bond tester (Fig. 73). The frame tee and longeron splice details were then bonded in place using vacuum pressure and the compressed air heater. The completed repair is shown in Figure 74.
